# DEVELOPMENT OF ADVANCED LIGHTWEIGHT SYSTEMS CONTAINMENT FINAL REPORT

**MAY 1981**

GENERAL ELECTRIC COMPANY

NASA Lewis Research Center Contract NAS3-21823

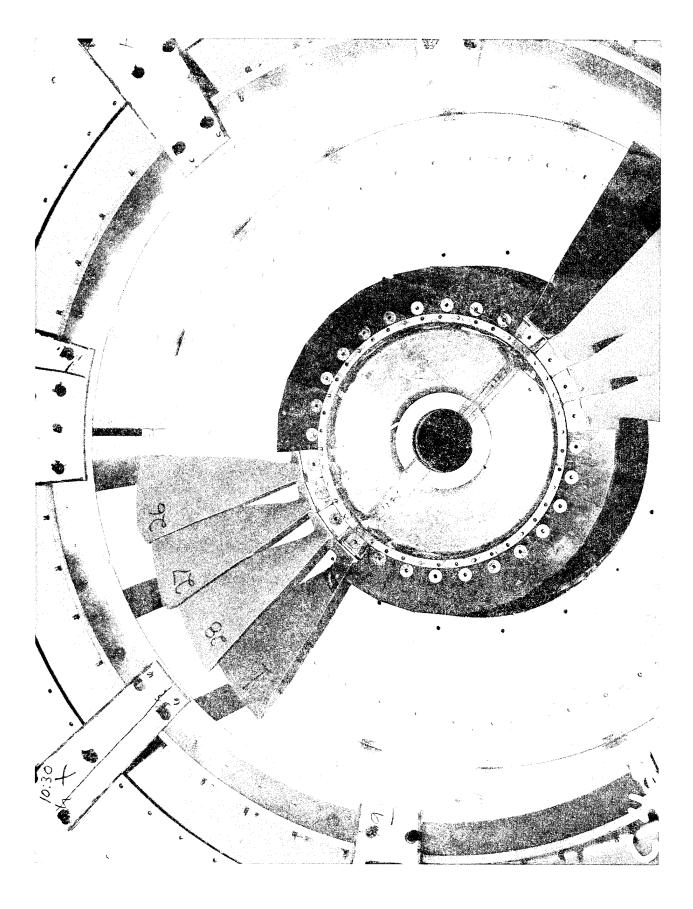
Figure 9. Test 1 - Overall View.

Two TF34 titanium airfoils were released at 4500 rpm into a containment configuration which had 12 plies of dry Kevlar in one 180°-side and eight plies in the other. The containment systems were of typical lightweight construction with a thin steel facing, aluminum honeycomb, Kevlar, and thin aluminum back sheet. It was estimated prior to the test that the side with 12 plies would contain and the side with eight plies would be penetrated. The test setup is shown in Figure 8. In the actual test, the side with eight plies was not penetrated although the aluminum back sheet was ruptured. There was not indication of contact with the witness plate. The rotor and containment systems after test are shown in Figure 9. Typical damage to the flowpath side of the casings is shown in Figure 10. The backside (aluminum outer sheet) of the 12-ply containment system is shown in Figure 11 and that of the eight-ply system in Figure 12. The difference in damage to the Kevlar cloth was not as noticeable, but a progressive teardown of the structures showed that the Kevlar in the side with eight plies was pulled much more toward the center of the containment system (pulled away from the forward and aft ends) indicating that there was significantly greater radial deflection of the Kevlar due to the airfoil impact.

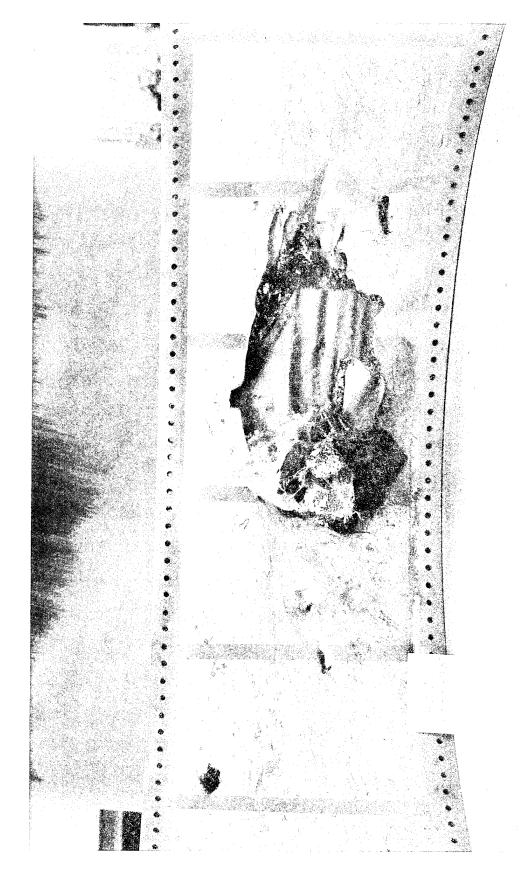
Figure 13. Interior View - 12-Ply Side - Test 2.

Since Test 1 did not result in penetration of the Kevlar systems, it was decided to run Test 2 with the same containment configuration as Test 1 and increase the rotor speed from 4500 rpm to 5000 rpm. This resulted in a 25% increase in the energy of the released airfoils. The damage of the flow-path side of the 12-ply configuration is shown in Figure 13. Comparing Figure 13 to Figure 10, which shows the damage to an identical containment case when impacted by an airfoil at 4500 rpm (Test 1), it appears that the damage is somewhat greater at the higher release speed and the airfoil is more deeply embedded in the containment. Teardown from the backside, however, did not shown any significant difference in the damage sustained by the Kevlar in Tests 1 and 2. It was obvious that threshold containment was not identified by these tests.

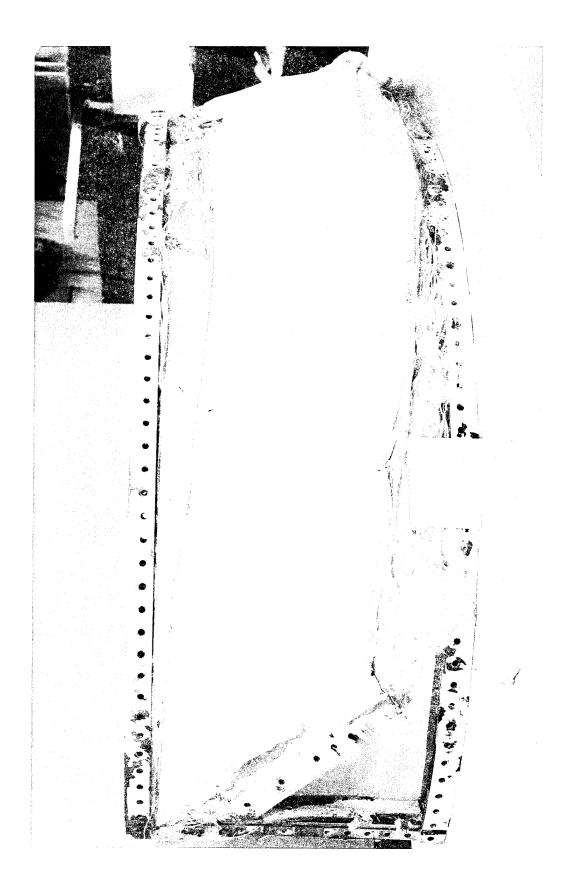
Figure 15. Exterior View - 12-Ply Side - Test 3.

This test was identical to Test 2 except that the blades were released below the platform resulting in a larger impacting mass and thus higher kinetic energies. The damage to the containment systems due to this test was much more severe than in Tests 1 and 2, but the blades were still retained by the Kevlar. The rotor/containment casing setup after the test is shown in Figure 14. Although the next following blade on each side interacted with the released blade and sustained a small dent in the leading edge near the root, no other damage was done to the remaining blades in the rotor. The back of the containment system containing 12 plies of Kevlar is shown in Figure 15 with the aluminum outer sheet removed exposing the Kevlar material. For the first time in the tests of this type, the impact had sufficient force to fail the axial joint of the Kevlar to the close-out beams. This joint was formed by locally rigidizing the Kevlar with epoxy adhesive and bolting it between the two steel bars which form the axial close-outs. The failure consisted of a combination of bolt failure and shear-out of the Kevlar/epoxy as shown in Figure 15. This phenomenon occurred only on the side which had 12 plies of Kevlar. On this side, the blade did not locally penetrate the Kevlar. The Kevlar plies moved outward as a unit thus applying a circumferential force which had to be resisted at the ends. This load was apparently

sufficient to fail the end attachment. On the side with only eight plies of Kevlar, the blade root punched a hole entirely through the Kevlar although the blade as a whole was contained within the system. In this case, much of the energy was absorbed by fracturing the Kevlar and was thus not transferred circumferentially to the end attachments which did not fail. The eight-ply side, with the aluminum backing removed, is shown in Figure 16. As would be expected, the external damage, as can be seen by comparing Figures 15 and 16, was greater on the side that had less Kevlar. This difference in damage can also be seen in Figures 17 and 18 that show the interior of the containment specimen at the outer radius of the honeycomb sandwich of the 12-ply and eight-ply systems, respectively, where all the dry Kevlar has been removed.

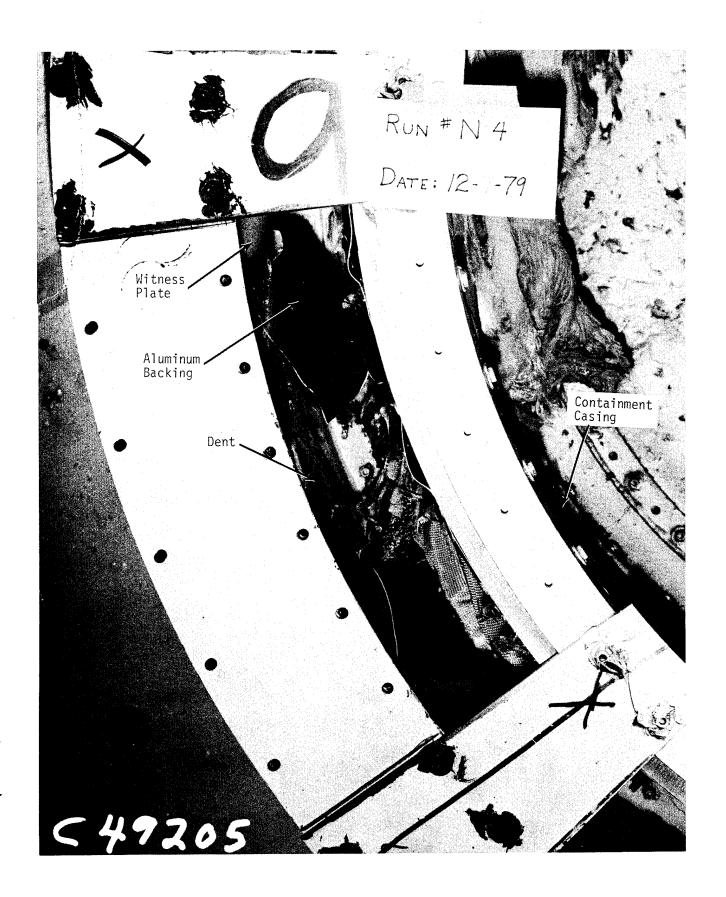
Figure 19. Witness Plate Dent - Test 4.

Since Test 3 did not completely defeat the system, even though the eight plies of Kevlar were just barely able to retain the blade, it was decided to increased the speed at which the blade was released to the maximum that could be obtained in the existing test setup. This speed turned out to be in the vicinity of 5300 rpm. The actual release speed was 5285 rpm and the containment targets were of the same configuration as Test 3. The damage to the containment systems was very similar to that noted in Test 3 with slightly greater penetration of the blades through the Kevlar. On the side with eight plies of Kevlar, the outward movement of the released blade was sufficient to impact the witness plate with considerable force. The dent left by this impact can be seen in Figure 19. Although the blade remained captured by the containment systems, it is questionable if it would have remained captured if its motion had not been stopped by the witness plate. The outside of the containment rings, with the aluminum back sheets removed, is shown in Figures 20 and 21. As can be seen in Figure 20, the blade root did not penetrate the outer plies of the 12-ply configuration while the root section came completely through the eight-ply Kevlar belt as shown in Figure 21. In both cases, the Kevlar material, at the point of impact and for a considerable distance circumferentially away from this point, was drawn toward the center (axially) of the containment ring. This movement left large areas unprotected in the event of subsequent impacts. Several methods of restricting this movement were experimentally evaluated later in this program.

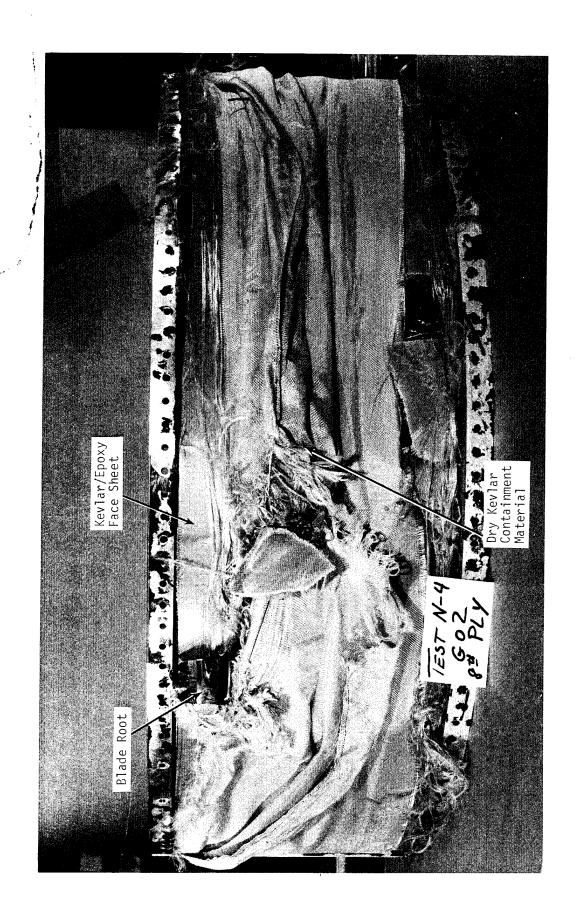
Figure 21. Exterior View - Eight-Ply Side - Test 4.

The superhybrid that impacted the side that had eight plies did not completely penetrate the Kevlar cloth; however, the more aft direction of the blade moved the Kevlar cloth considerably aft as shown in Fiugre 39. This damage can be compared to that caused by an all-titanium blade released under the same conditions into an identical containment system during Test 4 as shown in Figure 21.

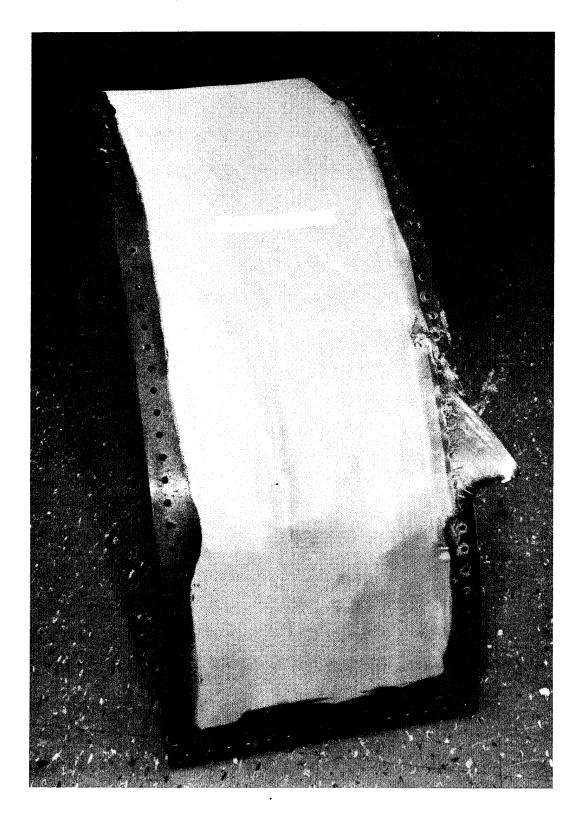
Figure 27. Exterior View - 10 Plies of 328-Weave Kevlar - Test 6.

Two TF34 titanium blades were released below the platform at 5300 rpm. Both blades were contained by the containment systems and the end retention feature worked very well. There was no tendency for the Kevlar to be pulled out of position. This was a significant improvement over previous tests as can be seen by comparing Figure 27 which shows the damage to the side with 10 plies of 328-weave Kevlar with Figure 20 of Test 4 which was conducted under the same conditions with a containment system of 12 plies of Kevlar which were not restrained in the axial direction.

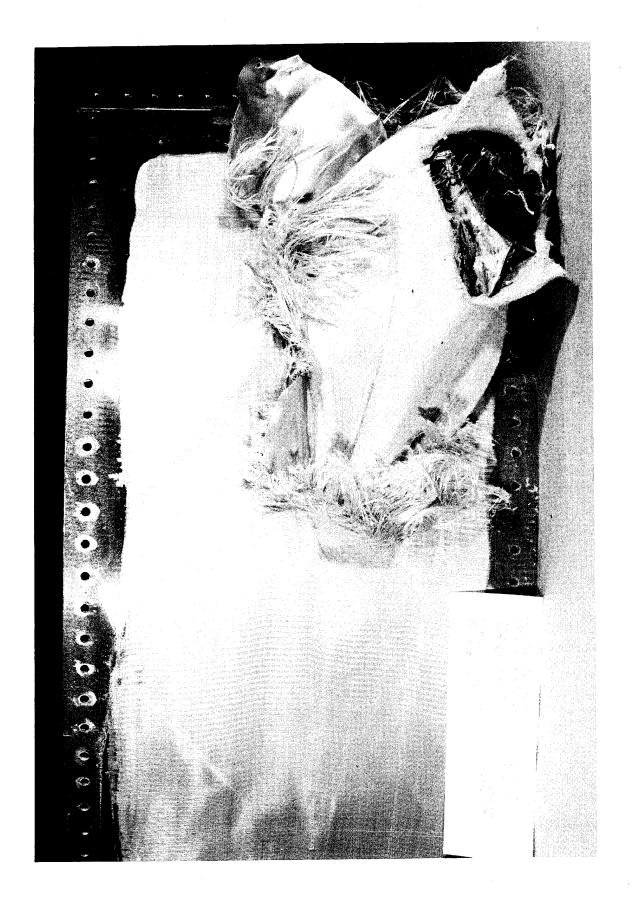
Figure 33. Exterior View - Test 8 - 143-Weave Cloth Plus Felt.

Although the heavier felt did not tear nearly as readily as the lighter felt used on previous tests, the blade roots punctured both the felt and the woven cloth on both specimens. As with the previous test using the 143-weave cloth, there was a splitting tendency due to the small number of transverse (axial) fibers allowing the released blade, encased in the felt except for the root section, to virtually escape from the containment system (Figure 33). The blade would probably have come out except that the root struck the witness plate preventing further radial motion. The damage to the witness plate can be seen in Figure 34. The system with 328 weave was not as severely penetrated but the root section did come completely through the containment in a manner similar to Test 7. Although the heavier felt may have helped some (compare Figure 35 which shows the damage from Test 8 with Figure 32 from Test 7), it was a marginal improvement. This blade too may not have been retained in the containment system if it had not struck the witness shield.

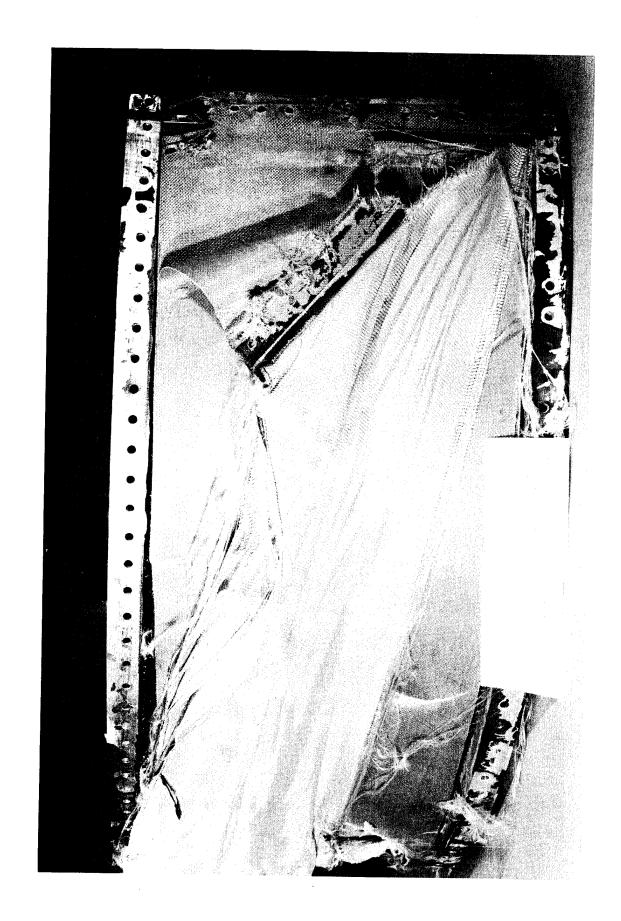
Figure 40. Broken Circumferential Restraint - Test 9.

Test 8 was the second test in which the circumferential restraint was broken as shown in Figure 40. This is probably why the root section did not penetrate through the Kevlar cloth; since, with the circumferential restraint

released, the cloth was free to move radially outward without adding additional strain to the fibers. If this restraint had remained intact, it is expected that the root section would have penetrated the eight plies of Kevlar in a manner similar to that shown in Figure 21.

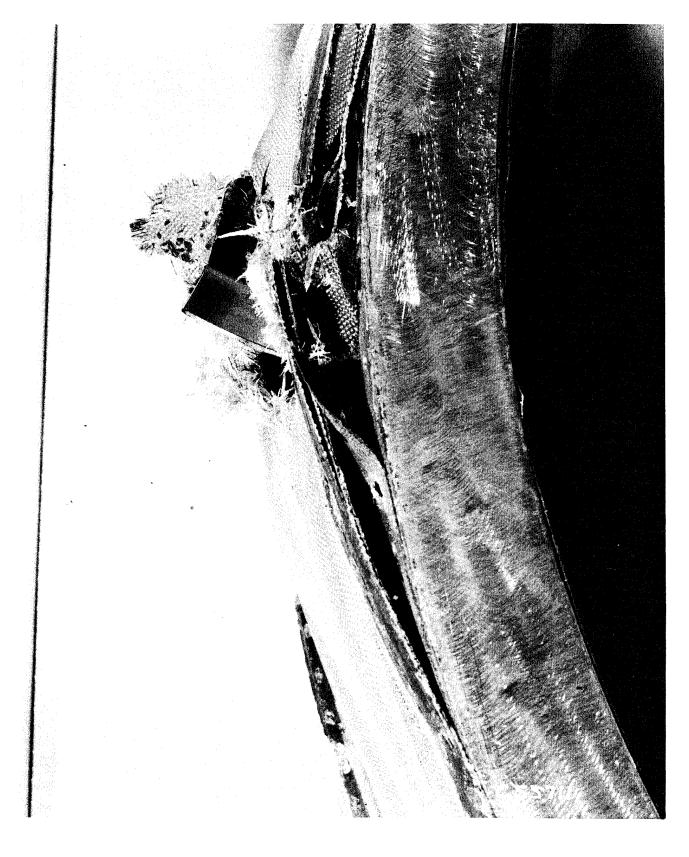
Figure 44. Blade Platform Penetration - Test 11.

Although the blade was well contained, a corner of the platform was protuding through the outer Kevlar plies. If the criteria of no penetration in a commercial application is abdered to, two more plies of Kevlar would be required for this design. Otherwise, the test was very successful and the casing stood up well to the conditions imposed by the high rotor unbalance.

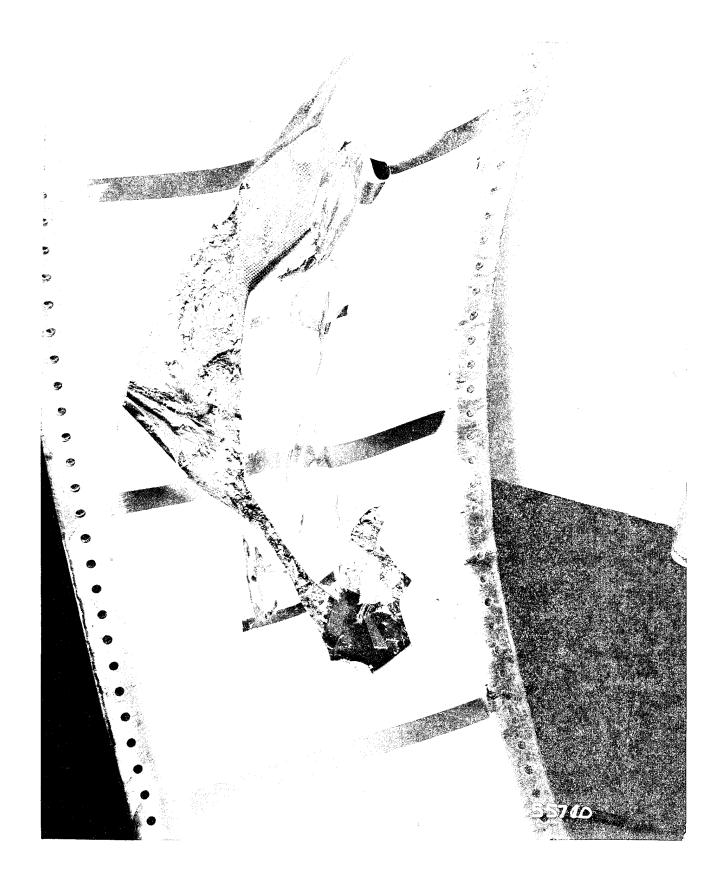
Figure 46. Impact Area - Test 11.

Test 6. The damage in the impact area was typical and is shown in Figure 46. The rotor unbalance due to the blade loss was sufficient for the rotor blade tips to rub on the inner surface of the containment case. A typical rub area can be seen between 6 o'clock and 9 o'clock in Figure 47. A closeup of this area is shown in Figure 48. The face sheet was locally grooved, and there were several small circumferential cracks (Figure 48) but nothing which would significantly degrade the structural integrity of the case. In spite of the impact and the tip rubs, the casing remained round.
